JURISDICTION

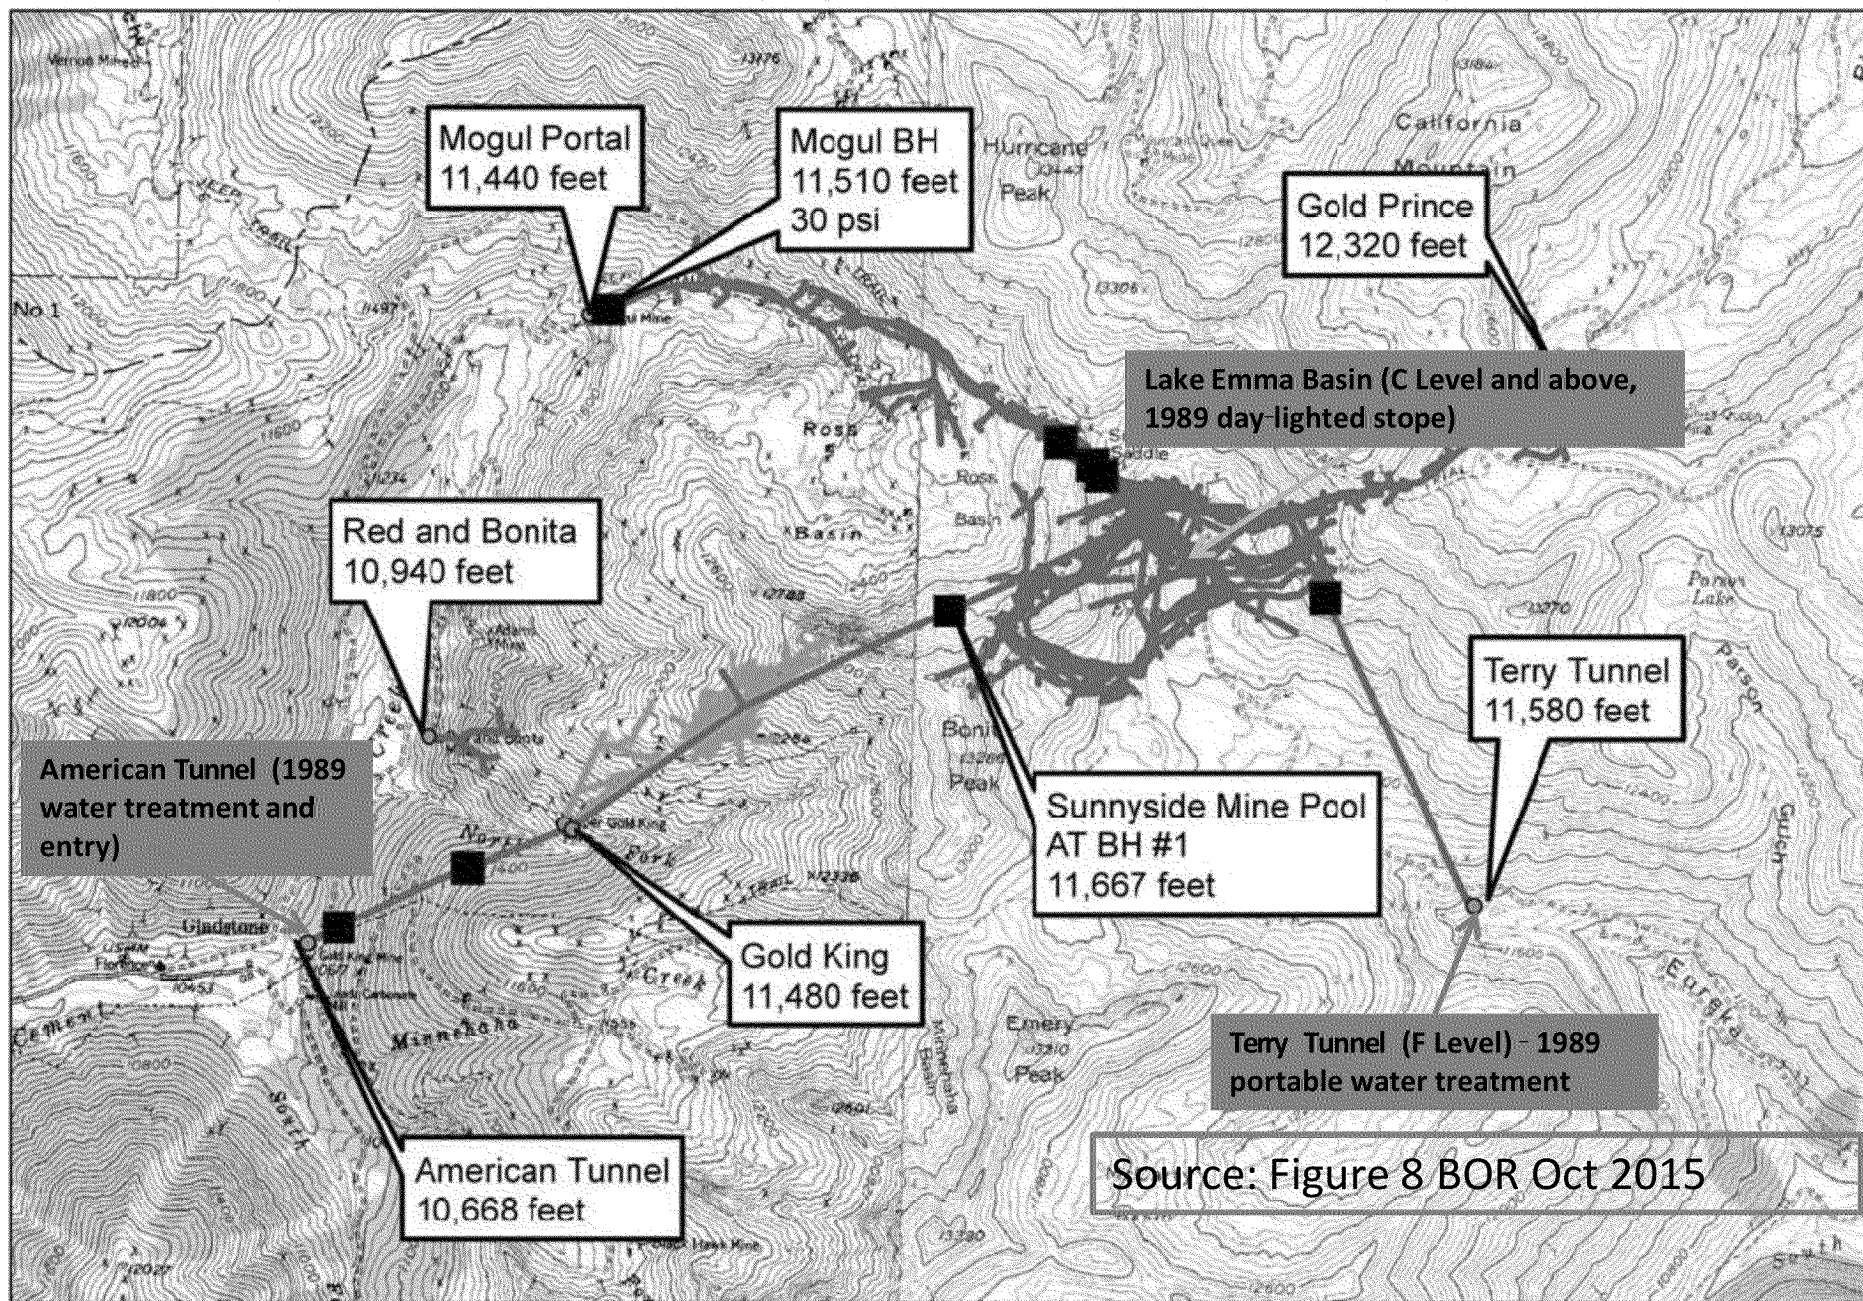
EXHIBIT C

Mine and Pool Elevations

the upper Animas—define the Upper Animas River Basin. The river basin contains hundreds of inactive or abandoned mines, among them the Gold King Mine, on the slopes of Bonita Peak, and the much larger Sunnyside Mine, two miles west in Eureka Gulch. Bonita Peak and the surrounding topography is a maze of faults, fissures, and fractures—both natural and manmade. *See Exhibit C.*

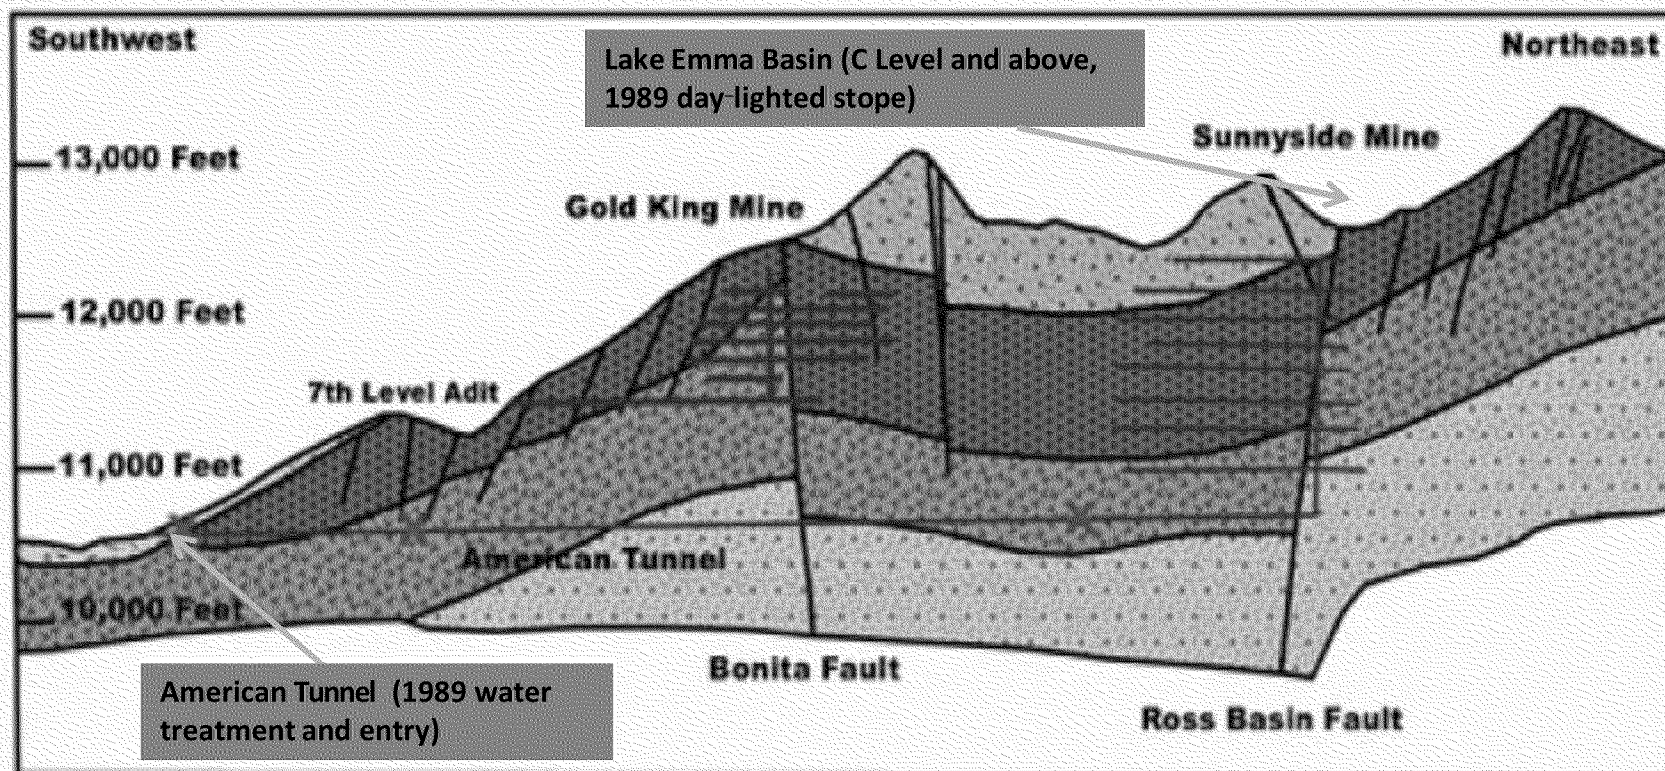
EXHIBIT D

Modified from U. S. Geological Survey
Professional Paper 535, Plate 6

X Bulkhead
